Manhole Inspection Summary

Manhole # S51AA_026MH

Insp Date: **7/17/08 12:04 PM**

Location Address: **rear 735 n kenwood av**

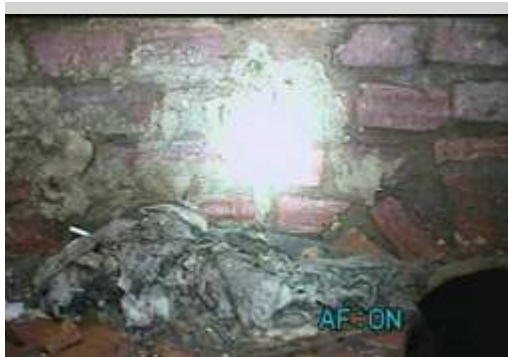
Misc

bench debris

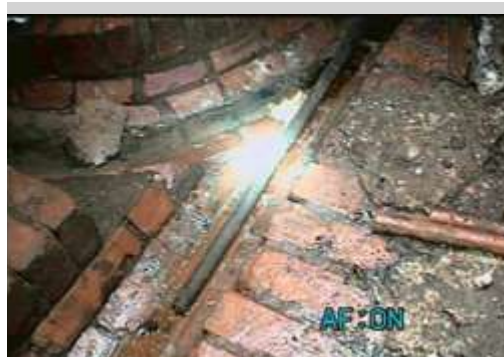
Misc

channel debris

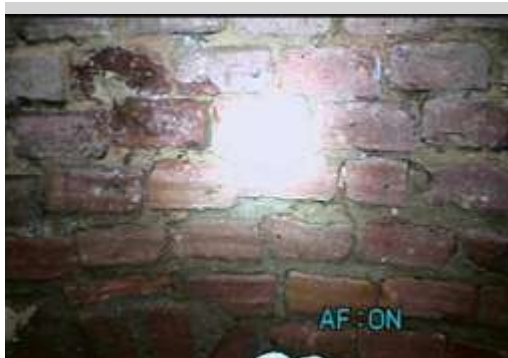
Defect 5

Condition: ☐ Sound ☐ Cracked ☐ Root Intrusion ☒ **Loose Brick** ☐ Deteriorated

loose bricks barrel

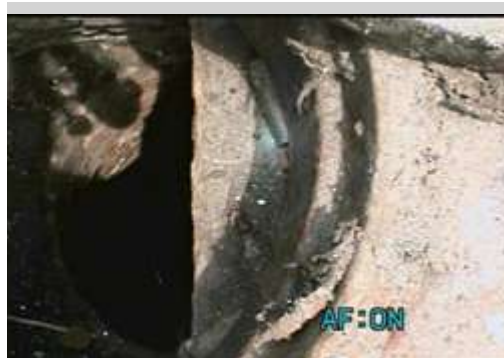
Defect 3

Frame Offset: **7** (in.) Condition: ☒ Sound ☐ Cracked ☐ Leaks

offset

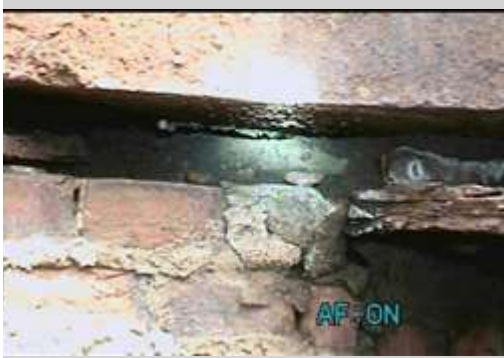
Defect 2

Condition: ☐ Sound ☐ Cracked ☐ Root Intrusion ☒ **Loose Brick** ☒ **Deteriorated**

chimney_cond_deteriorated_loose bricks
frame adj

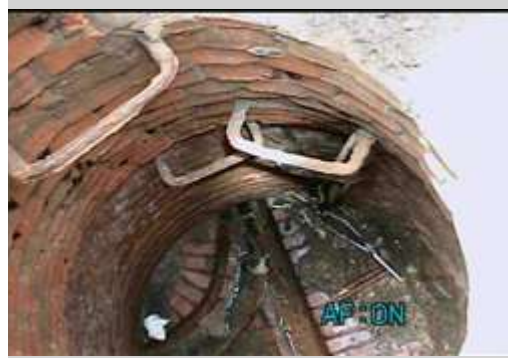
Defect 1

Steps Count: **4** Missing: **0** ☒ **Corroded**

corroded steps
